Yima City Gasification Plant Incident

Yima City Gasification Plant

Air Separation “C” Explosion

July 19, 2019, 17:43

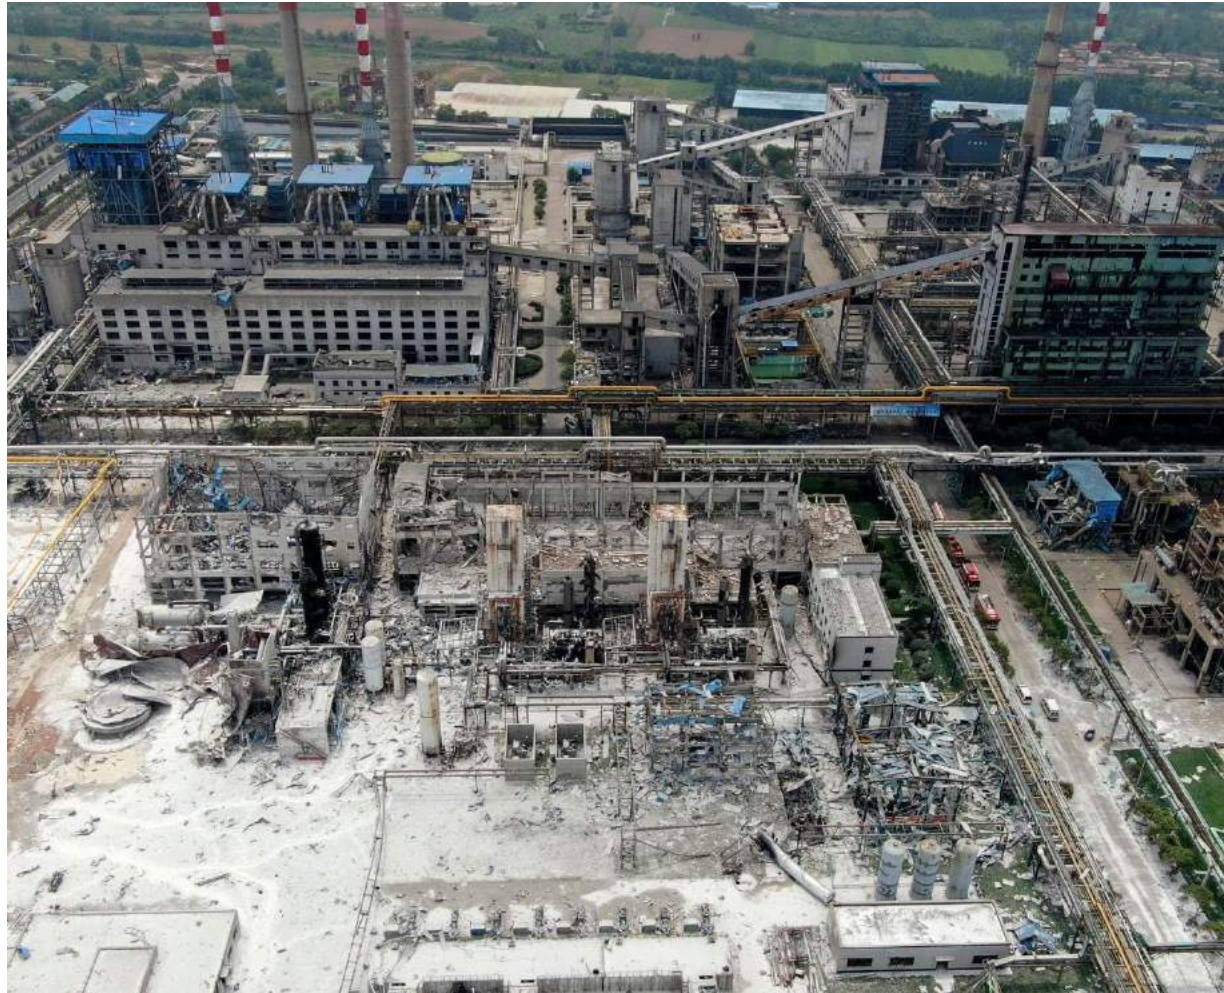
Aftermath (2)

- 15 deaths
- 16 seriously injured
- 236 hospitalized
- Direct economic loss of 81.7 Million RMB (\$12,000,000)

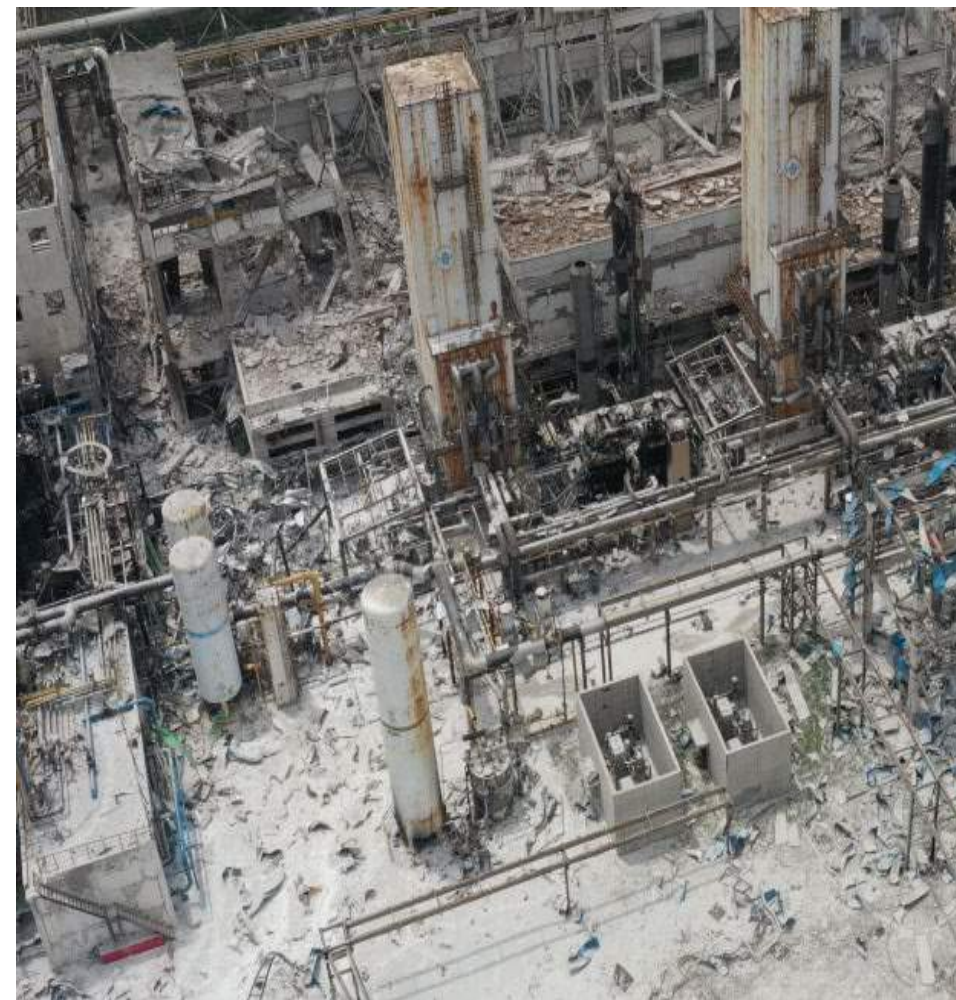
Conclusions (1)

- **Liquid leaked into the coldbox annular space as evidenced by the elevated oxygen levels**
 - Leak was reported over an extended time period as pressure and purity increased over several days

- Source of the leak is unknown, but it is expected in the process at or above the reported coldbox casing crack elevation
- **Perlite is released from the coldbox due to a rapid increase in the annular space pressure**

- Could have been caused by perlite movement as a result of loss of containment due to a crack low in the coldbox casing from embrittlement
 - Could have been caused by the original process leak rapid expansion releasing liquid or vapor at a high rate into the annular space

- Could have been caused by an ignition or energy release due to the high oxygen content in the annular space from contaminated perlite which was previously handled, or flammable material left behind in the insulation

- Could be unrelated to the original leak such as a loss of process containment in another section, reboiler flash from a hydrocarbon/liquid oxygen reaction or an enriched oxygen line burns

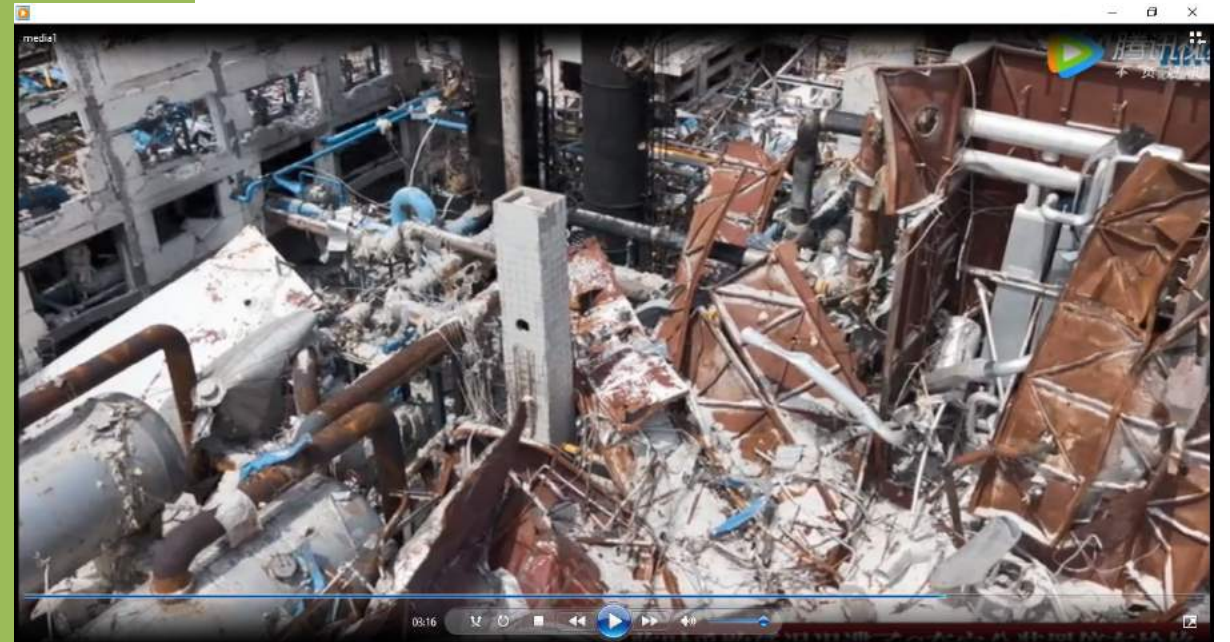
Conclusions (2)

- An “energy release flash” about 38 meters up the coldbox around on the northeast side near a platform soon after the perlite releases begin. The cause is unknown; however, it is in the same area as one of the very first perlite releases and not mentioned in any of the published documents
 - Could be from a fire inside the coldbox
 - Could be from a fire outside the coldbox at an electrical junction box, etc.
- Perlite releases then become more prevalent and violent from many other Cold Box casing locations
 - Could be from additional embrittlement failures
 - Could be from over pressure failures

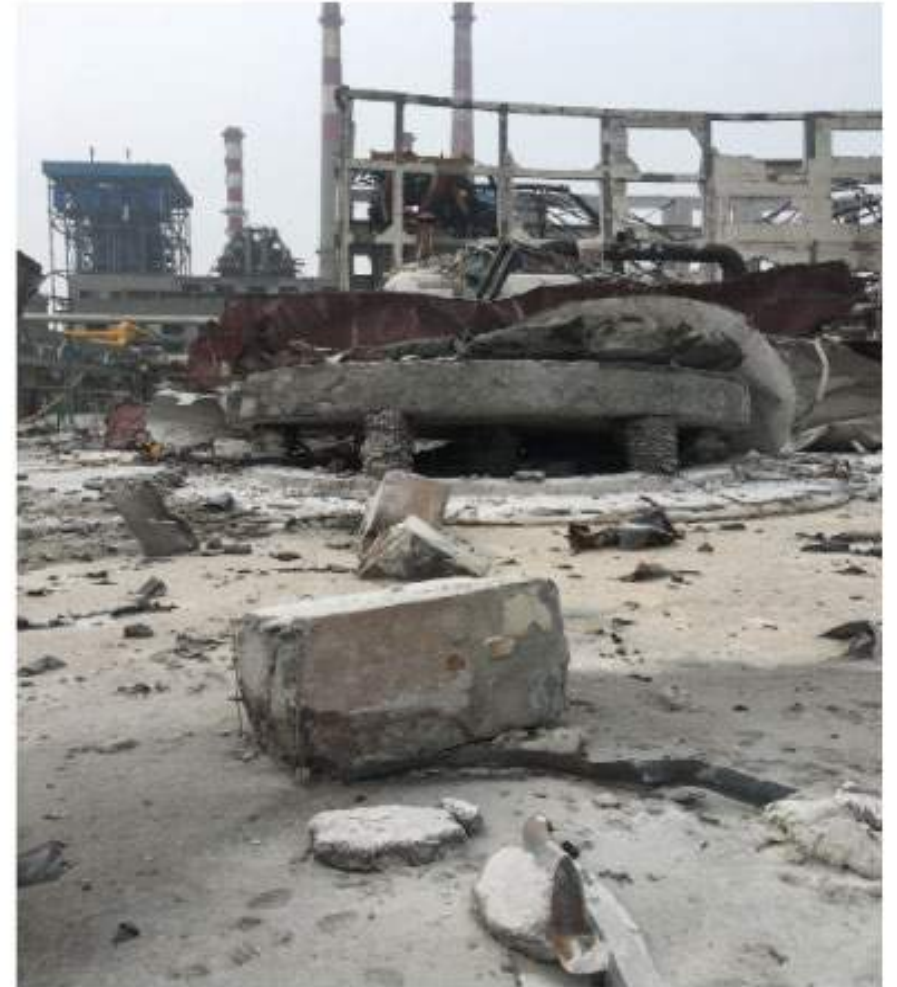
Conclusions (3)

- **Coldbox collapses and internal columns fall from unknown mechanisms**
 - Failure due to embrittlement
 - Failure due to over pressure
 - Combination of both embrittlement and over pressure
 - Structural design issues
- **Ignition sources for the initial and at least two (2) follow up explosions unknown**
- **Evidence of aluminum reboiler core explosion**
 - Sections of cores are found northeast, southeast, and southwest of the center of a referenced explosion point on the ground near the liquid oxygen bulk storage tank
- **Possible burning of aluminum packing**

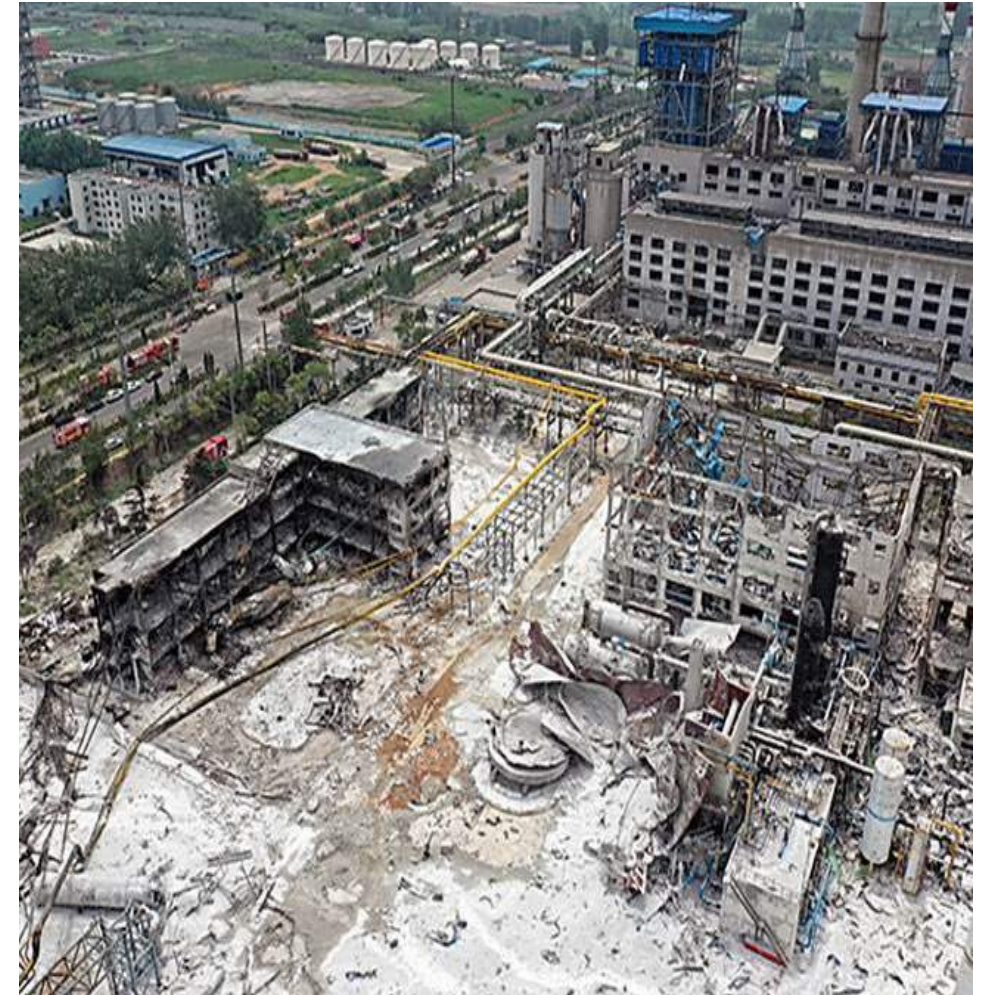
Direct cause of the incident as reported by the Henan Provincial Emergency Management Department - June 12, 2020

- A leak in the interconnecting pipe of the coldbox valve in Air Separation Plant C
- Process leakage into the perlite insulation
- Over pressurization of the coldbox results in a violent blast
- Support frame and coldbox plates are cold and brittle
- Coldbox collapses smashing into the bulk liquid storage tank and the adjacent Liquid distribution truck's oxygen and fuel oil tanks
- Liquid oxygen leaks together with available combustibles (aluminum, etc.) in the area resulting in a violent explosion
